# Manhole Inspection Summary

Manhole # S43C\_\_031MH

**Location** Address: **Broadway**

Cross Street: **Fayette**

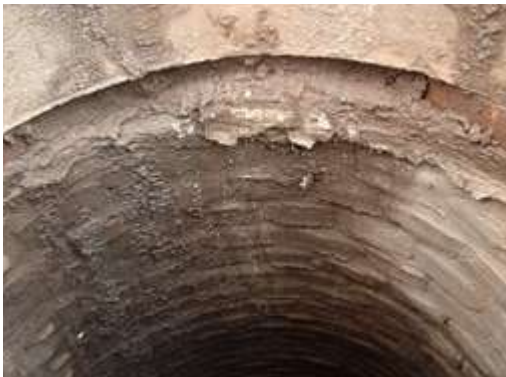
Defect 1

Infiltration: ☐ None ☐ Joint ☐ Cracks ☐ Mortar ☐ Roots ☒ **Wall**

Infiltration

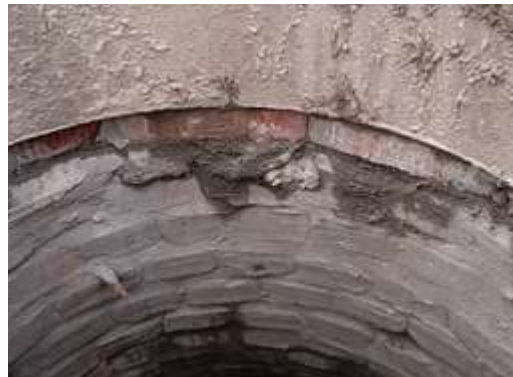
Defect 2

☒ **Leaks**

Frame Leaks

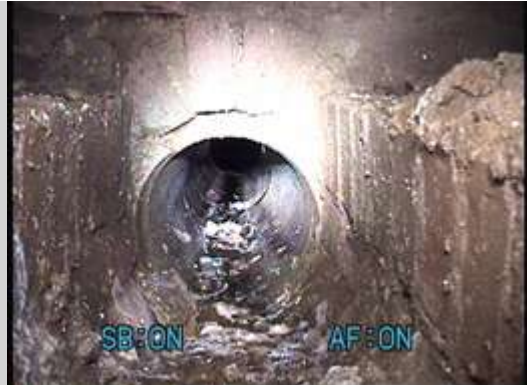
12 O'Clock Outflow

12 in. Circular Gravity Sewer  
Pipe Out @ 12 O'Clock

Pipe Height: **13.2** (in.) Rod and Bar (Angled)  
Pipe Material: **Clay** ☐ Pipe Lined  
Invert Depth: **11.50** (ft.) Flow Characteristics: **None**  
Deposits: ☒ None ☐ Mud ☐ Sludge ☐ Debris ☐ Grease  
Silt Depth: (in.) Deposits Extent:  
Infiltration: **None** Pipe Seal Cond: **Sound**

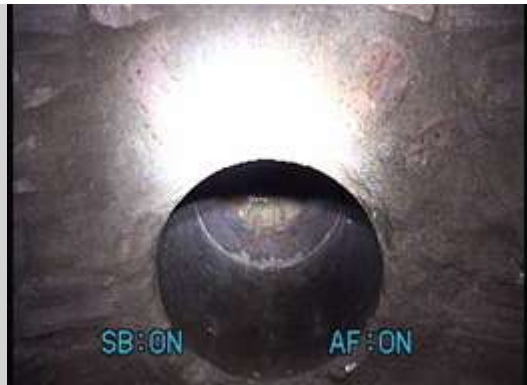
6 O'Clock Inflow

10 in. Circular Gravity Sewer  
Pipe In @ 6 O'Clock

Drop In @ 6 O'Clock

Pipe Height: **10.8** (in.) Rod and Bar (Angled)  
Pipe Material: **Clay** ☐ Pipe Lined  
Invert Depth: **9.10** (ft.) Flow Characteristics: **None**  
Deposits: ☒ None ☐ Mud ☐ Sludge ☐ Debris ☐ Grease  
Silt Depth: (in.) Deposits Extent:  
Infiltration: **None** Pipe Seal Cond: **Sound**

Drop: **Outside** Rod and Bar  
Angled: **Yes** Reading: **9.70** (ft.)  
Inv Depth: **10.70** (ft.)
